DAVIS-BESSE NUCLEAR REACTOR

*Ohio Sierra Club Nuclear Free Committee
Pat Marida, chair patmarida@outlook.com
December 2019*

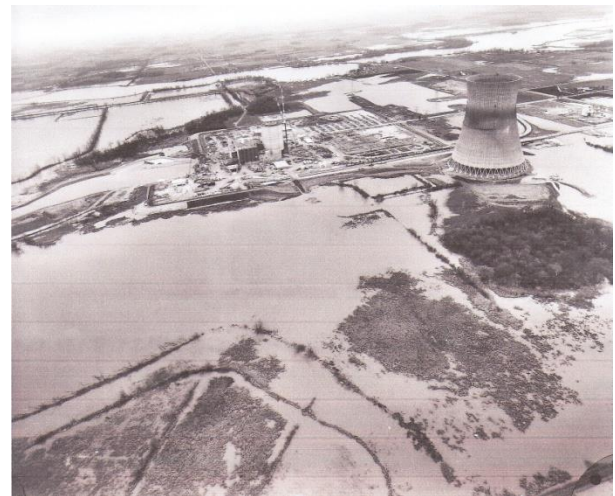
Davis-Besse construction site floods in 1972.

- In 1972 a strong wind caused lake water to flood the construction site for a month. A repeat with the reactor in operation could be disastrous.
- Davis-Besse has had six “significant accident sequence precursors” out of 34 total in the U.S.

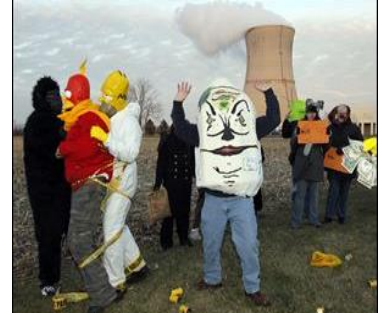
Humpty Dumpty is Cracked

SHIELD BUILDING CRACKING AND VOIDS: In 2011, evidence showed that the concrete shield building around the reactor was cracking. FirstEnergy maintained that the cracks were “architectural, not structural.” The NRC allowed a restart without knowing the cause of the cracking.

- The shield building has been cut into 4 times to replace aging parts. Each cut further weakened the building, causing 26 sections of rebar to be broken or cracked.
- In 2012 FirstEnergy said that cracks occurred because a failure to paint the building allowed the blizzard of 1978 to force water into the concrete which then froze. They insisted that cracks were not spreading. Inquiries later found that FirstEnergy had evidence of cracking a year before the blizzard.
- In a later report, FirstEnergy noted that cracks are spreading. Causes? A new paint job had sealed in water, which was freezing and thawing. Use of the wrong type of cement and the plumb of the building being outside of tolerance also contributed.
- In 2014 a honeycomb void was found in the concrete, measuring 25 feet long and between 6 and 12

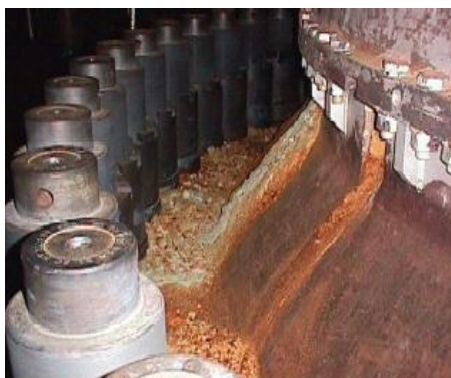
This is what inspectors ignored.

- In 2002 a delayed inspection found that boric acid had eaten through 7 inches of the steel reactor lid, with only a bulging 3/16-inch steel liner preventing a radioactive catastrophe. A photo was found, taken earlier, that showed major corrosion on the outside of the vessel, but this was ignored. This “Hole-In-The-Head” fiasco resulted in the largest fine in NRC history – \$33.5 million. The plant was idled for 2 years, costing ratepayers \$600 million.

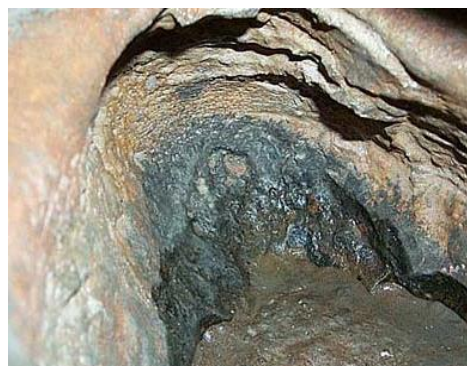
Later, this football-sized hole was found in the head of the reactor.
